INEEL/EXT-99-00743 (Rev 1)

November 1999

Status and Estimated Life of the 300,000-Gallon INTEC Tanks

**Idaho National Engineering and Environmental Laboratory
High Level Waste Program Division
Bechtel BWXT Idaho, LLC
Idaho Falls, Idaho 83415**

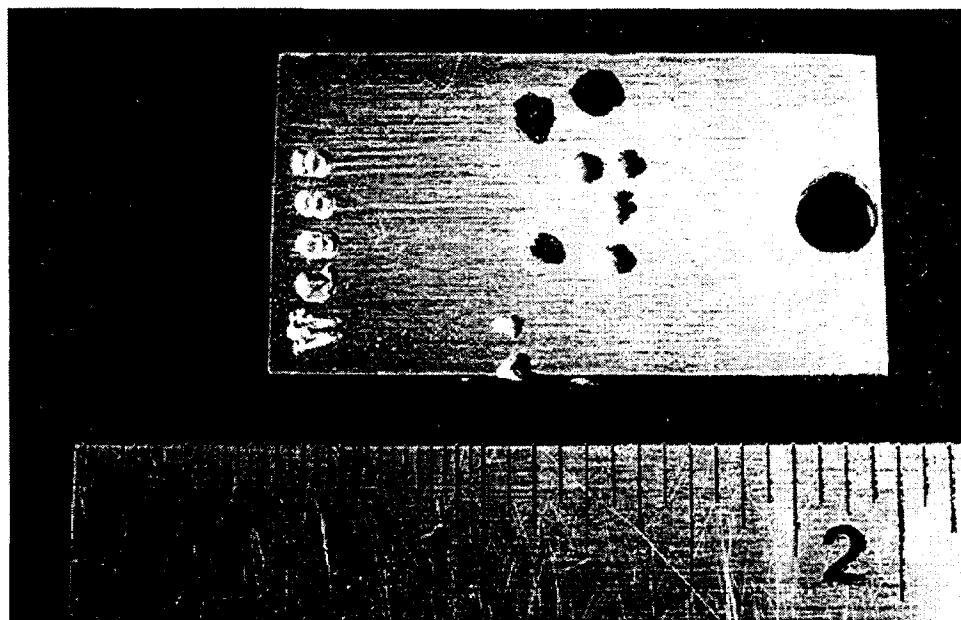
Figure 10 shows a 304L stainless steel coupon that was exposed to a ferric chloride solution. The pitting extends through the section thickness.

Figure 10. Pitting of 304L Coupon Exposed to Ferric Chloride

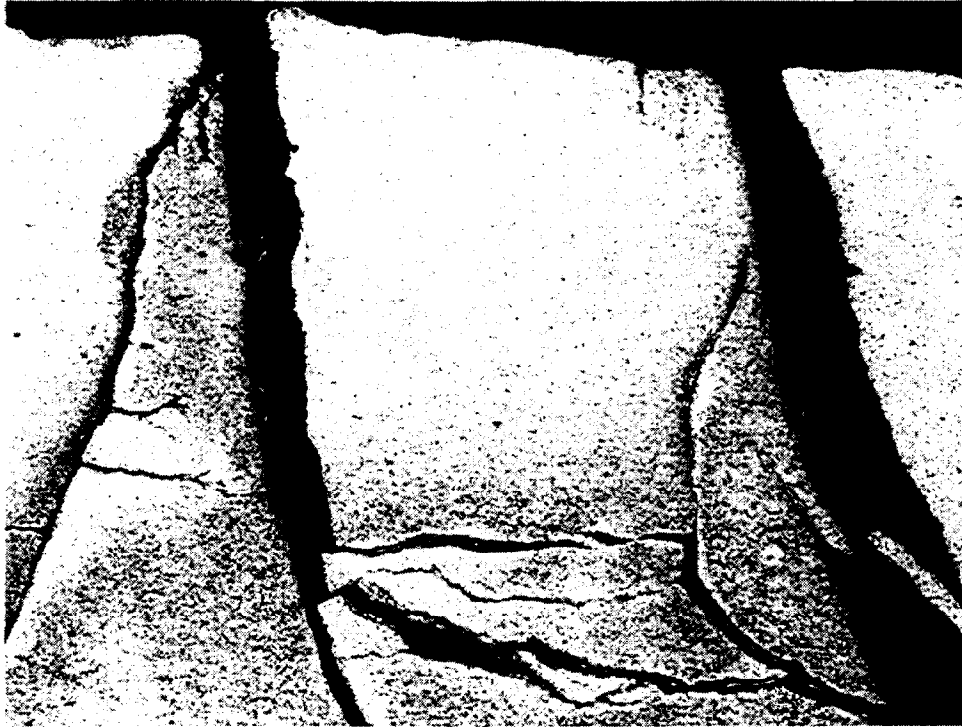
Figure 15 is a view of one of the areas of localized pitting/cracking that was cut out of the metal wall and prepared for microscopy. The photograph shows a magnified view (37.5X) of the wall cross section.

Figure 15. Enlarged View (37.5X) of a Crack

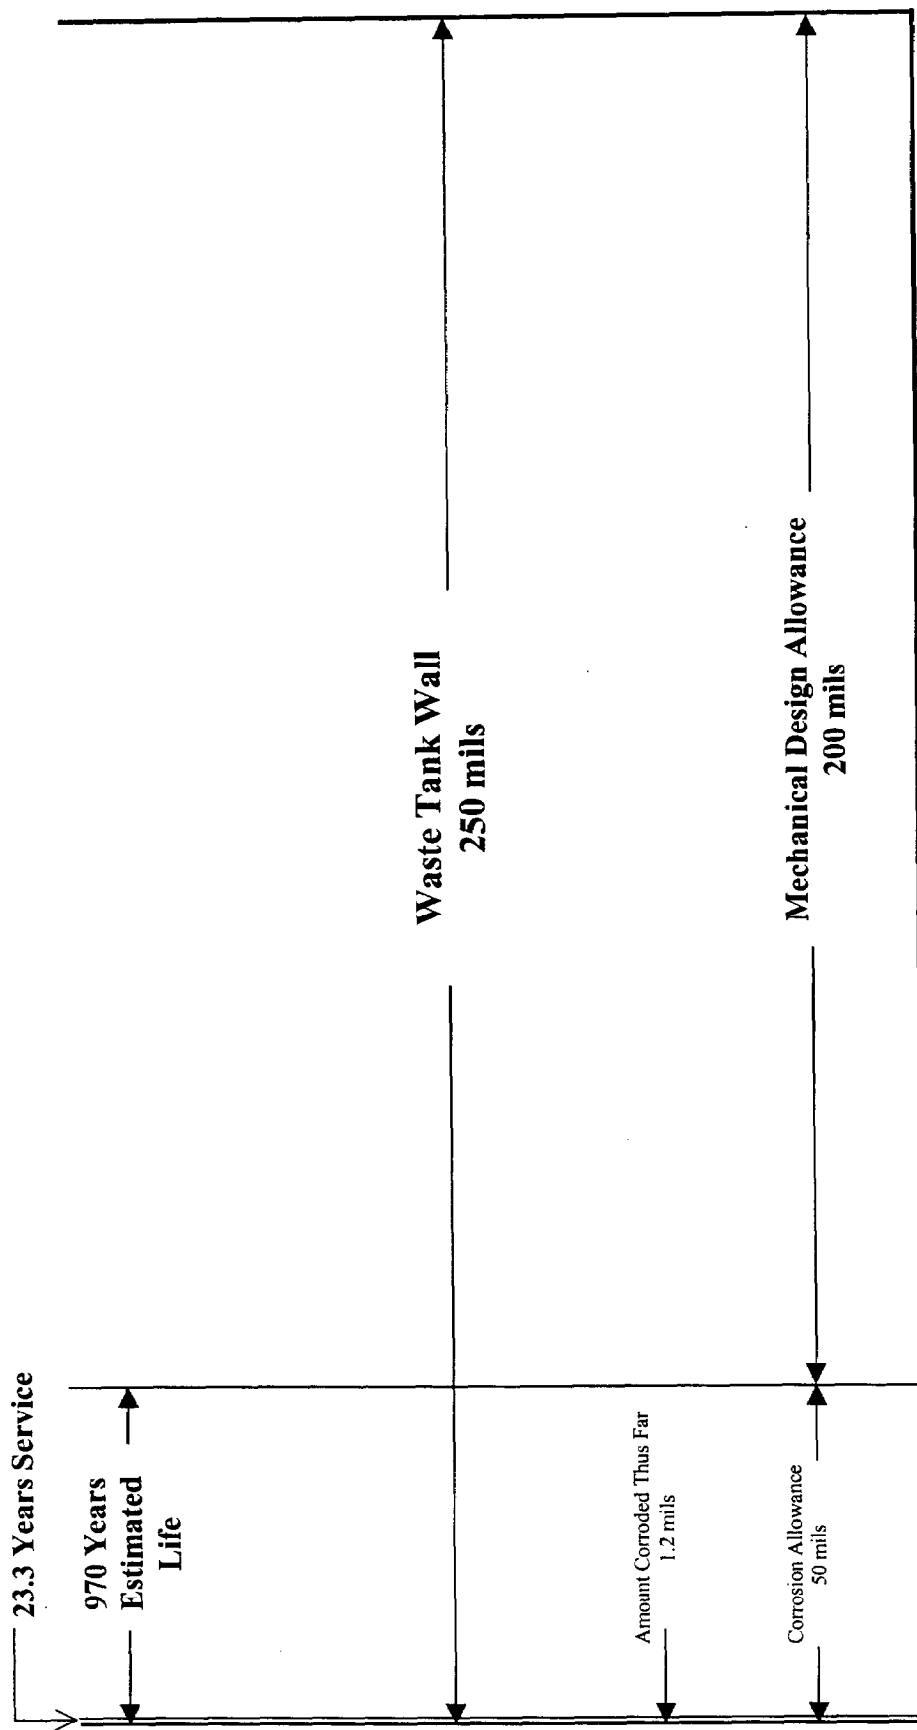
The results from the latest (1988) full corrosion coupon evaluation (Reference 7) indicate that the uniform corrosion rates of test coupons recovered from these tanks are not excessive. As shown in Table 3, the highest corrosion rates have been sustained in the tanks used for storage of the zirconium first-cycle wastes. Corrosion coupons from the three tanks being used for this service (WM-187, -188, and -189) show average uniform corrosion rates of 7.9×10^{-3} to 5.3×10^{-2} mil²⁰ per year with an average rate for the three tanks of 2.9×10^{-2} mil per year. The maximum corrosion rate observed in first-cycle zirconium waste was for Tank WM-188 with a rate of 5.3×10^{-2} mil per year indicated by coupons at both the 36- and 72-inch exposure levels. Calculations based on this maximum observed uniform corrosion rate in 1988 indicate a maximum metal loss from the internal tank surfaces of 1.2 mil over the WM-188 service life of 23.3 years. This maximum metal loss of 1.2 mils is small compared to the design corrosion allowance of 125 mils or the revised corrosion allowance of 50 mils that resulted from the seismic studies (see Section 4.3). Figure 27 graphically shows this extremely small amount of corrosion compared to the corrosion allowance and mechanical design allowance of the vessel. It should be noted that if the corrosion allowance were consumed or penetrated, there would still be the 200-mil (0.200-inch) mechanical design allowance left to preclude leakage.

Figure 27. Scaled Drawing of the Maximum Corrosion in the Waste Tanks

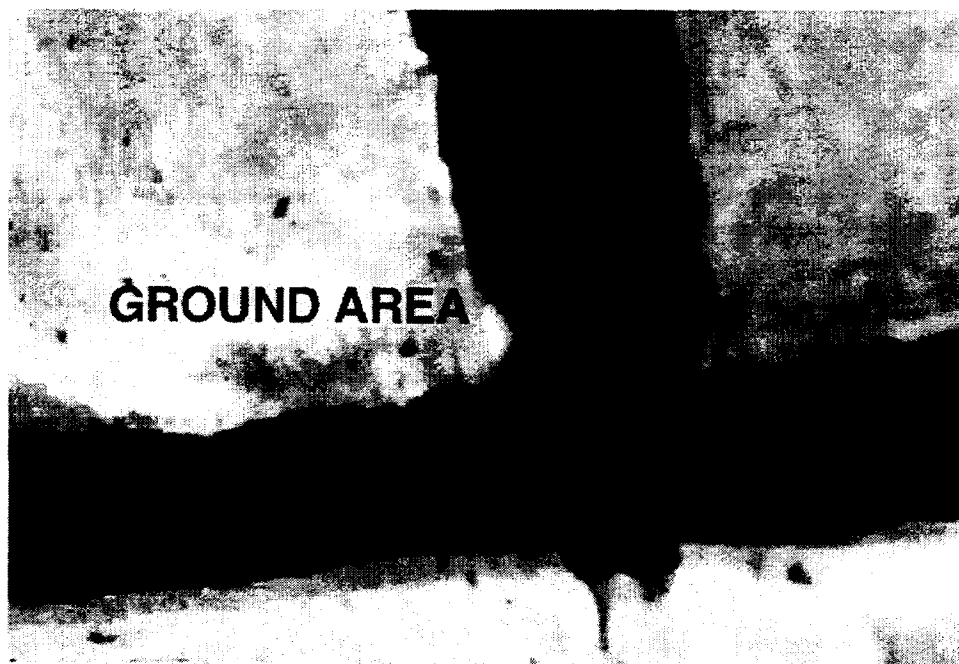
A video inspection system was deployed into WM-188 by the LDUA in February 1999. The inspection concentrated on accessible areas containing welds that are considered the most likely areas for the initiation of localized corrosion. The inspection technique was to scan the walls for visual evidence of localized corrosion as shown in the preceding pictures. A typical weld area is shown in Figure 31 that shows the intersection of two welds. This area would be exposed to high heat input from the intersecting welds that will increase susceptibility to intergranular corrosion. The weld joint area would also be an area of high residual tensile stress. There is no evidence of intergranular corrosion or cracking in the weld heat affected zone. There are black spots on the surface of the weld and base metal that appear to be surface deposits but this cannot be confirmed with a two-dimensional inspection technique. The shiny area to the left of the weld intersection appears to be a grinding mark from the original fabrication.

Figure 31. Weld Intersection in WM-188

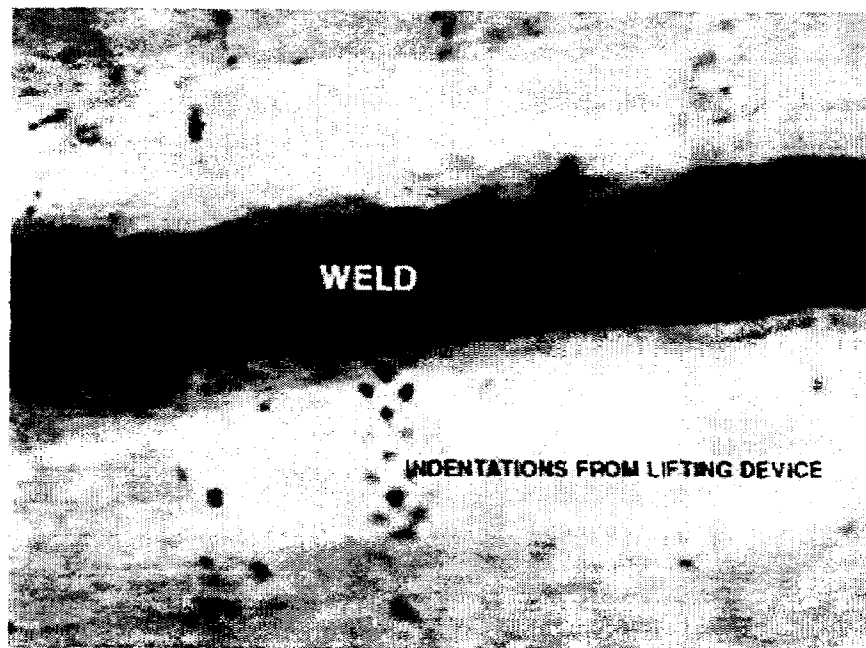
Figure 32 shows a horizontal weld. There are indentations in the plate next to the weld. These are believed to be marks where a mechanical lifting device fastened to the plate as shown in Figure 33. There are other spots on the surface that cannot be measured for convexity or concavity.

Figure 32. Areas of Mechanical Damage from Initial Tank Erection

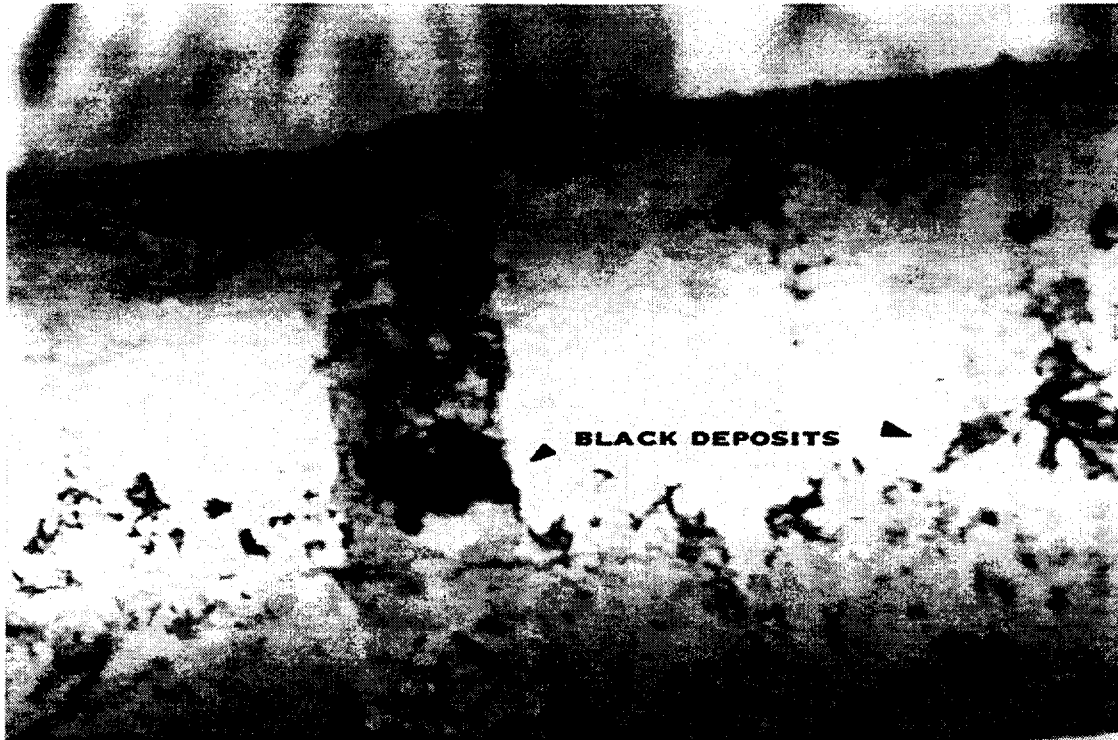
The tank walls and internal cooling coils of Tank WM-188 were covered with surface deposits as shown in Figure 34. The first deposit shows up as a lighter tone of gray in the video. It covers much, but not all of the top surfaces of the stainless steel cooling coils. There is a second type of black deposit that appears on top of all surfaces in the tank as shown in Figure 34. There is no evidence of crevice corrosion of the pipe surface or weld from these deposits. The weld appears to have the proper crown and there is no evidence of a higher corrosion rate for the weld or the weld heat affected zone.

Figure 34. Cooling Coil Pipe Surface with Deposits

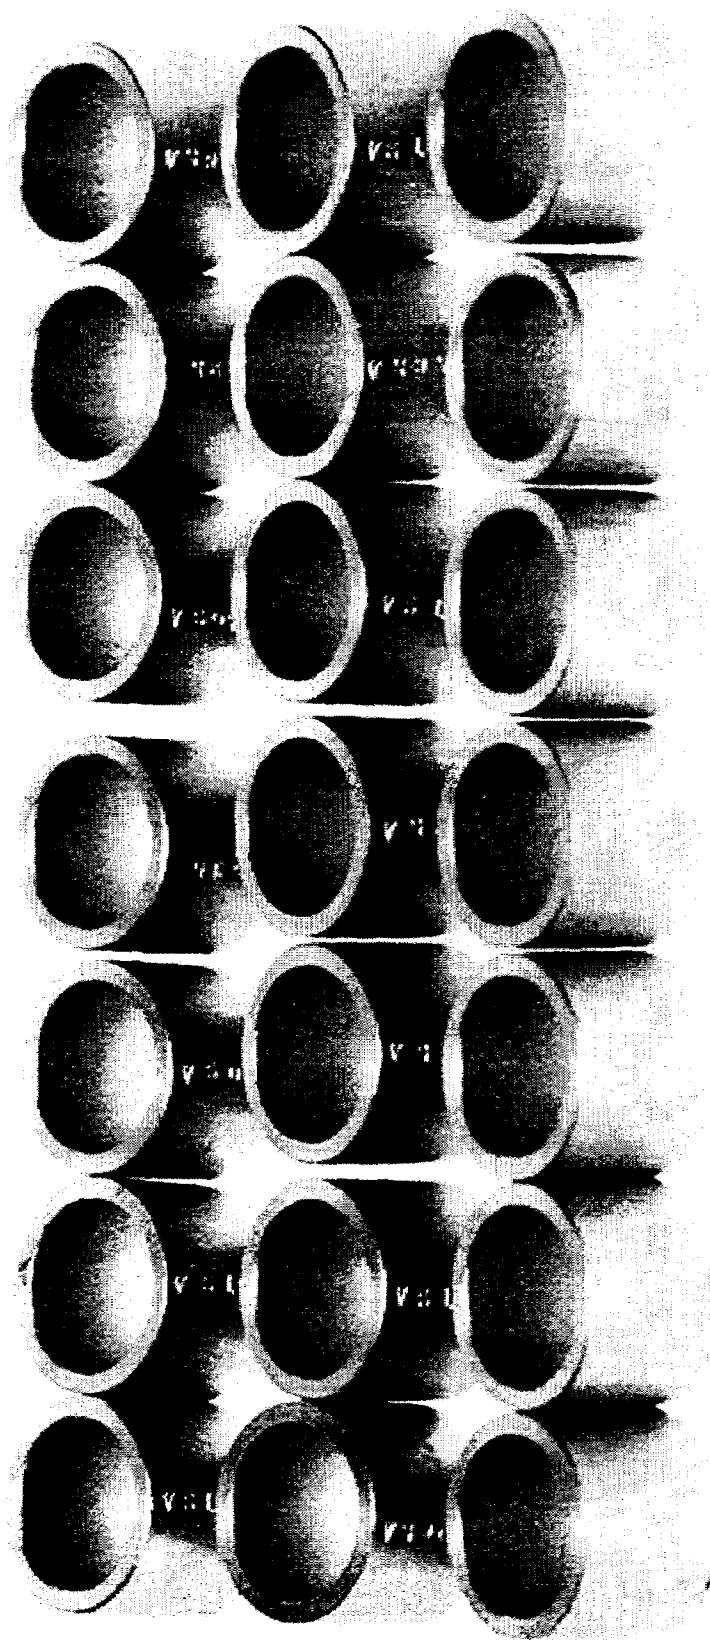
CORROSION COUPONS VESSEL WM-182
36 INCH DIAMETER 28.3 YEARS EXPOSURE

Figure 36. Coupons Retrieved from the 36-inch Level of Tank WM-182 in 1999
(Coupons made from 1-inch Sch 40 pipe)

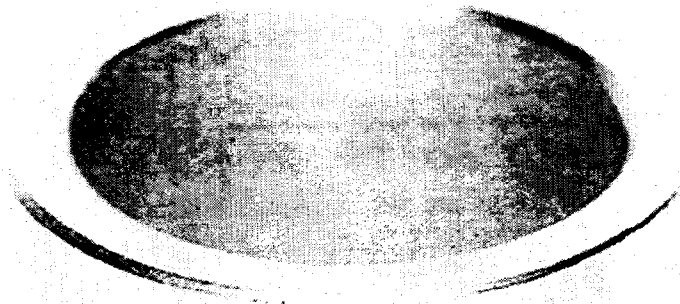
**WM-182 COUPON
72" LEVEL**

Figure 37. Coupon Retrieved from the 72-inch Level of Tank WM-182 in 1999
(Coupon approximately 1.3 inches outside diameter and one inch long)
